**LTPP Seasonal Monitoring
Program**

Site Monitoring Suspension
Status Report
Section 091803
Groton, Connecticut

CONNECTICUT SECTION 091803

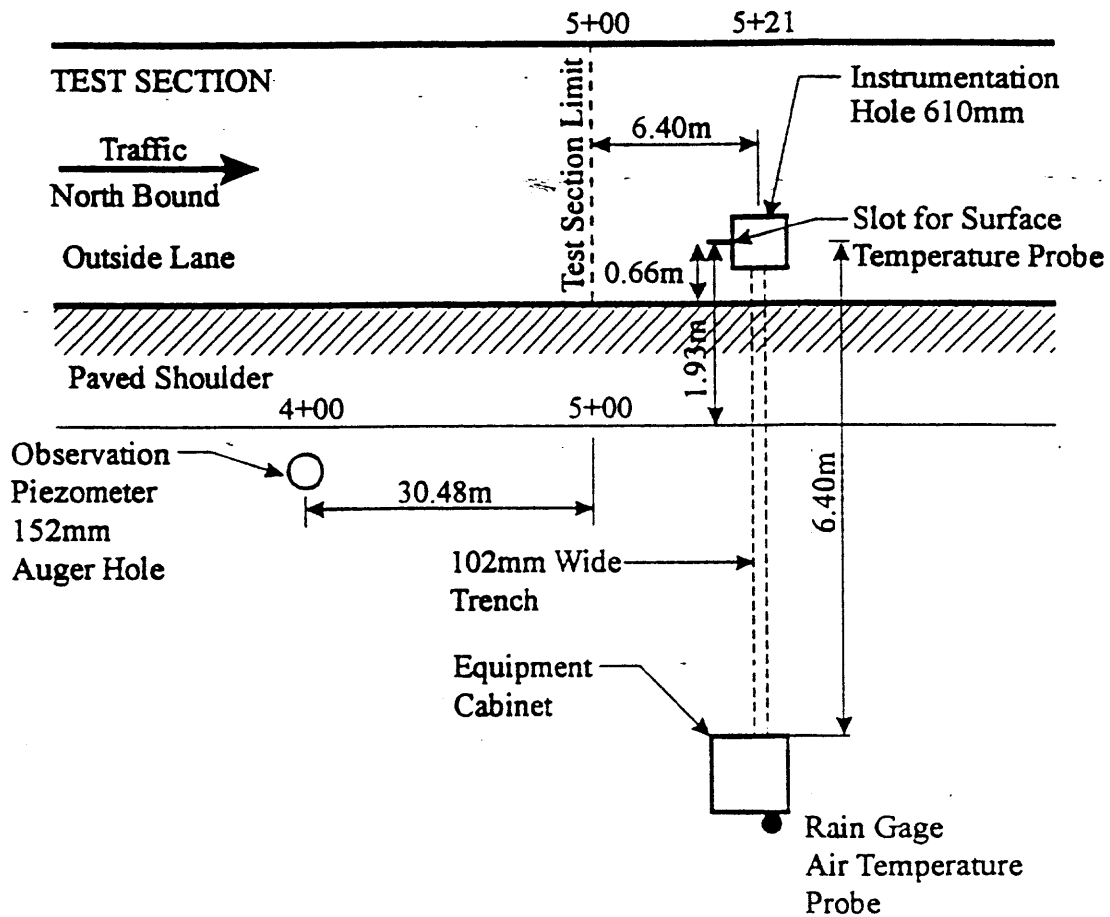
Figure 1. Location for Seasonal Monitoring Instrumentation Installed at GPS 091803

Figure 1 shows the locations of the installed instrumentation at the site. The instrumentation hole is at Station 5+21 and the piezometer is at Station 4+00. Table 2 gives the elevations of the portion of test section 091803 that was used for elevation measurements. All offsets are measured from the PK nails found at the outside pavement edge.
